Aviation Safety

Ultralight and Balloon

Issue 1/2000

Some Tips on Ultralight Pre-flight/Maintenance

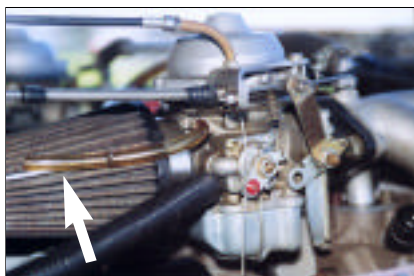
A well-maintained Rotax carburetor system can often have unexpected visitors; note the open vent line (arrow). Although necessary for correct operation of the carburetor, this is an inviting place for a worm or insect to nest. If one of these critters gets in there it can shut off the carburetor air balance and stop the engine. This is an important area to check during a pre-flight if the aircraft has not flown for an extended period.

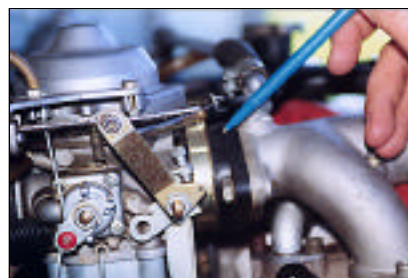
The pencil points to the rubber collar on the Rotax 912 carburetor attachment. This collar should be inspected frequently for cracks as it must be in good condition to seal the mixture flowing to the engine. Any cracks will allow air to suck through and lean the mixture, with corresponding engine performance degradation.

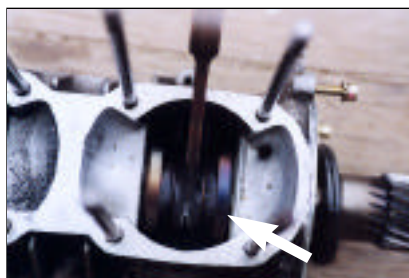
Additionally, the seal or collar on a two-stroke Rotax must be fastened securely because it holds the entire carburetor in position. Although many ultralights have two carburetors, both are required to balance the fuel flow to the cylinders. A failed carburetor on a two-stroke engine can starve half the engine of oil, as in this case, where a bearing failure in flight occurred (arrow points to bearing failure). In addition, the lean fuel/oil mixture causes an immediate rise in cylinder head temperature and often leads to piston seizure.

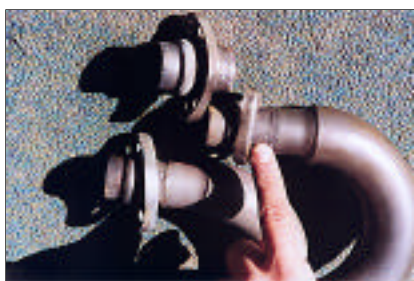
Cracks in the exhaust system become "breakaway components" very quickly during flight, and this can play havoc with the propeller if the aircraft is a pusher type. Always conduct a careful pre-flight for such indications. Note the finger pointing to a crack initiation.

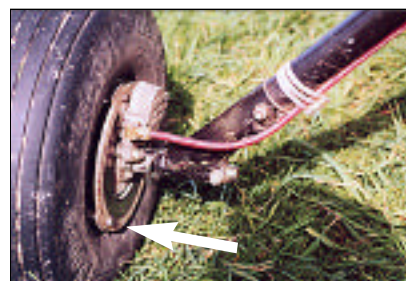
Brake disc fasteners left unlocked can work out and damage the brake-puck housing. If you are unable to use lockwire, use star washers or some other locking device. **Remember: if it can come out, it will come out.**

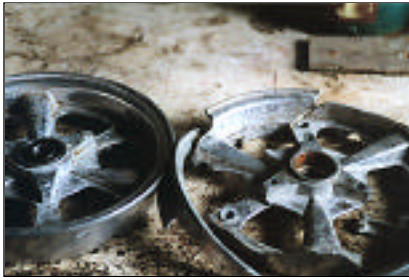
Some ultralight kits were delivered with very light aluminum alloy wheels to save weight. These types often fail in sideloads, so they must be monitored for signs of pre-cracking, particularly if operating off rough fields. The catastrophic failure of a wheel or axle usually results in severe damage to the undercarriage and a wing.

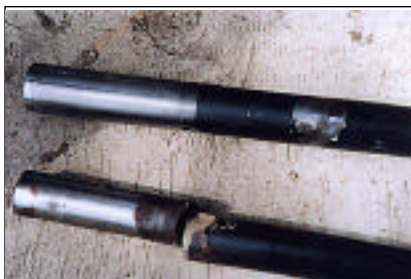
Speaking of broken axles or undercarriage legs, as this photo indicates, they can, and do, break from metal fatigue, particularly on rough-field operations and under conditions of excessive flexing over a period of time. ✂

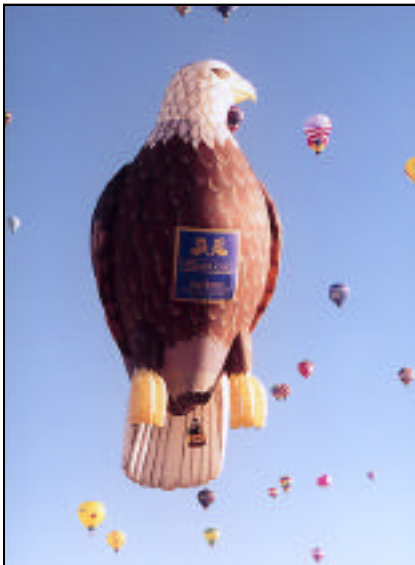
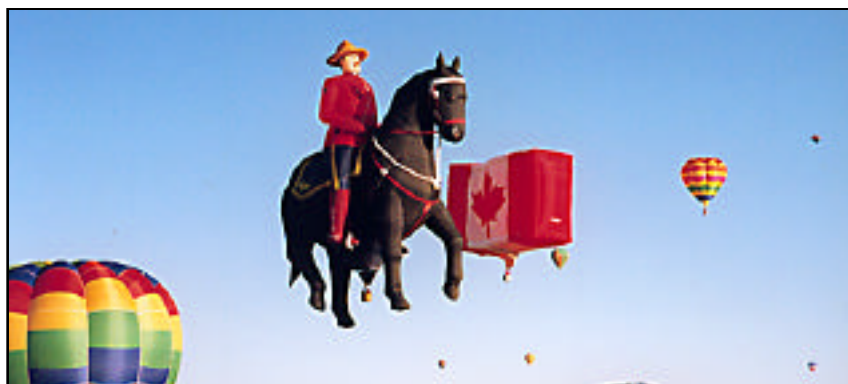
Both the Eagle and the Mountie on Horseback balloon envelopes, shown in the accompanying photos, were destroyed by a grass fire that was inadvertently set during the landing drag. The Mountie incident happened near Dallas, Texas, in October 1999. Apparently, the balloon landed normally, but during the drag a spark or residual flame from the propane burner ignited the dry grass along the landing path. Despite efforts to control the fire, both with the help of crew and

bystanders stomping the flames and the pilot with the balloon's hand-held fire extinguisher, the fire destroyed the envelope. The crew managed to save the basket by unhooking it and dragging it clear of the flames.

have their envelopes destroyed by grass fires they inadvertently set upon landing. *This is something to think about, particularly when landing in fields with dry, tall grass. The grass can ignite from the burner passing close to the ground. Since the wind is always astern during a drag landing, if a grass fire ignites, the wind helps it overtake the balloon. As well, the fire can be missed by the pilot because it is may be starting behind him/her and out of his/her immediate vision. In both these cases, the fire got a head start and the pilots were unable to control the situation. There were no injuries reported in either incident.* —Ed. 🍇

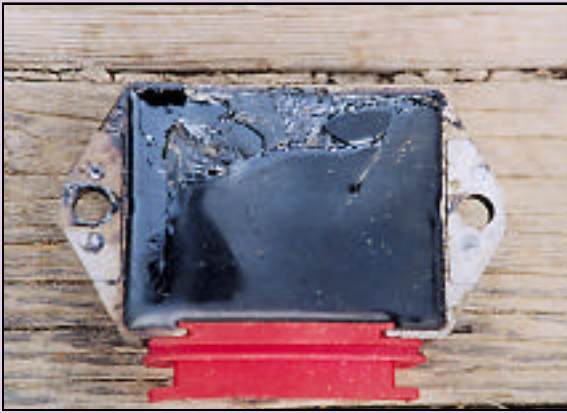
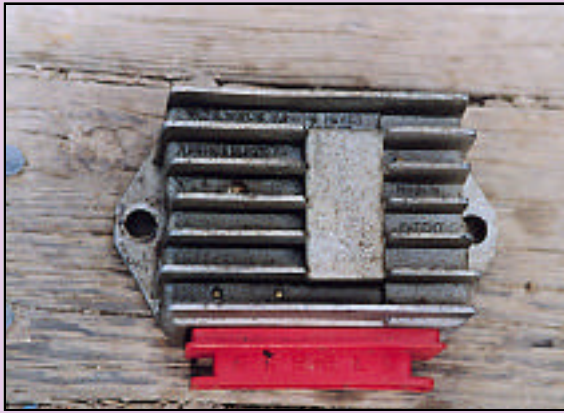
Bottom side of burned-out rectifier (left) with the type of rectifier identified in a top view (right).

Occasionally an ultralight or advanced ultralight pilot may be confronted with unexpected smoke in the cockpit. If the smoke has an acrid smell and other characteristics of an electrical fire, the problem may be the rectifier/voltage regulator self-destructing. This component is found in most ultralight or advanced ultralight aircraft equipped with Rotax engines. It does not have a service life so may be just getting old when it fails or it could be a faulty unit.

The pilot in this instance reported considerable acrid smoke but found no need for panic. He correctly assessed the problem, returned to the airport and landed the aircraft safely after the unit burned itself out, as shown in the photos.

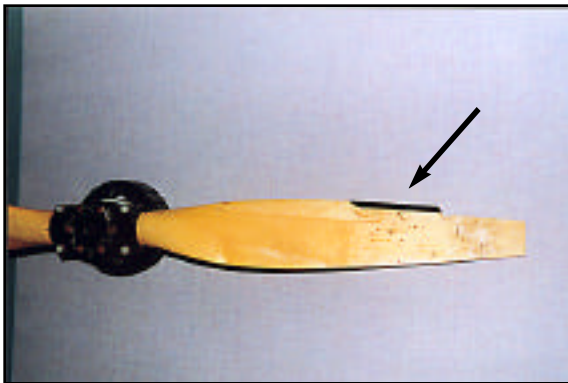
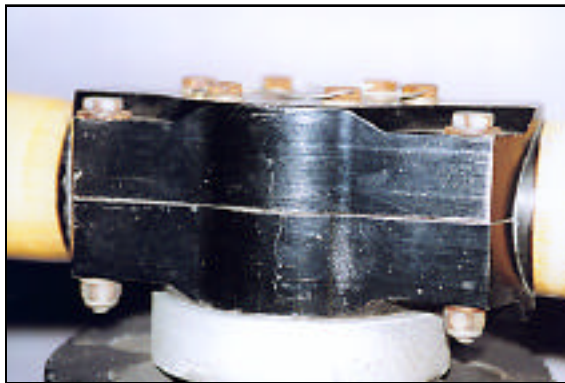
Evidence of blade strike (left) and the noted lack of clearance between hub halves (right). The manufacturer states that after the blades are torqued there should be some clearance between the hub halves for effective clamping of the blades.

This propeller was damaged during flight from striking something, as can be clearly seen at the indentation on the blade (arrow). Whatever hit the propeller split sections off both blades, making it impossible to provide thrust and sustain flight. Fortunately, the pilot was able to make a successful forced landing on a road without further damage to the aircraft.

An interesting point arises as a result of this incident. According to the manufacturer, this propeller hub requires some clearance between the hub halves after the blades have been torqued in place. The specified torque value is 75 in./lb, never to exceed 100in./lb. There appears to be no clearance visible on either side of this hub, so it can be concluded that either incorrect torque has been applied or the hub has been modified. Although this is not a factor in the broken blade, the fact that the hub halves may be incorrectly installed or torqued could have resulted in loss of a blade in flight.
